WEBSTER MEETING HOUSE HISTORIC BUILDING ASSESSMENT

1220 BATTLE STREET
WEBSTER, NEW HAMPSHIRE
JUNE 2020

Assessment of Condition (with graph of moisture conditions)

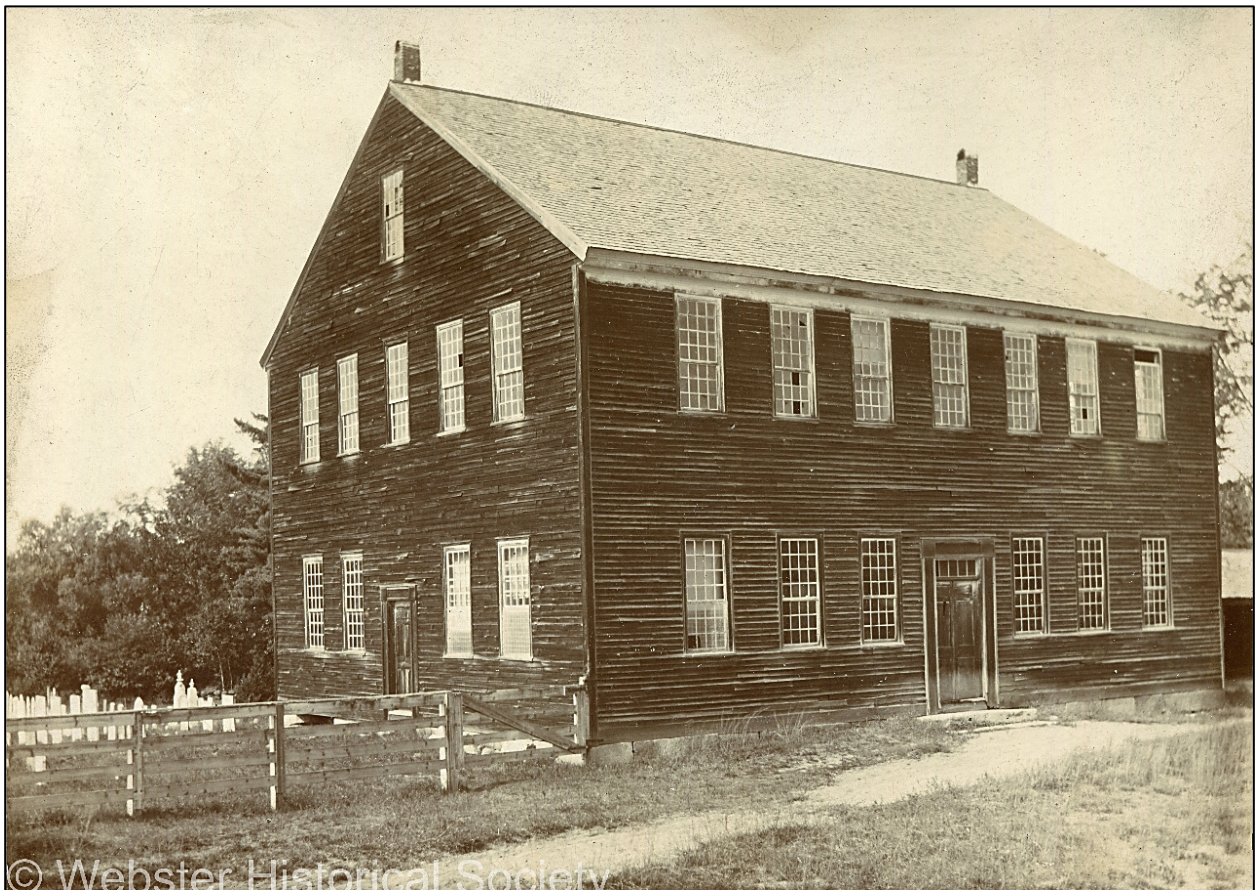
This photograph shows that the building had once been painted with white lead and linseed oil. Remnants of that paint remain under the cornice and on window casings and sashes. But lead paint erodes slowly over time, and very little pigment is seen on the clapboards of the building, many of which had been aged by unprotected exposure to the sun. It seems likely that many of these clapboards dated from 1844, and some of them possibly from 1791. It is also possible that the clapboards were never painted white, but rather were covered with a less expensive red or brown pigment, which would not be visible in a black-and-white photograph.

Webster Meeting House with weathered clapboards and remnants of lead-and-oil paint, circa 1899. Webster Historical Society

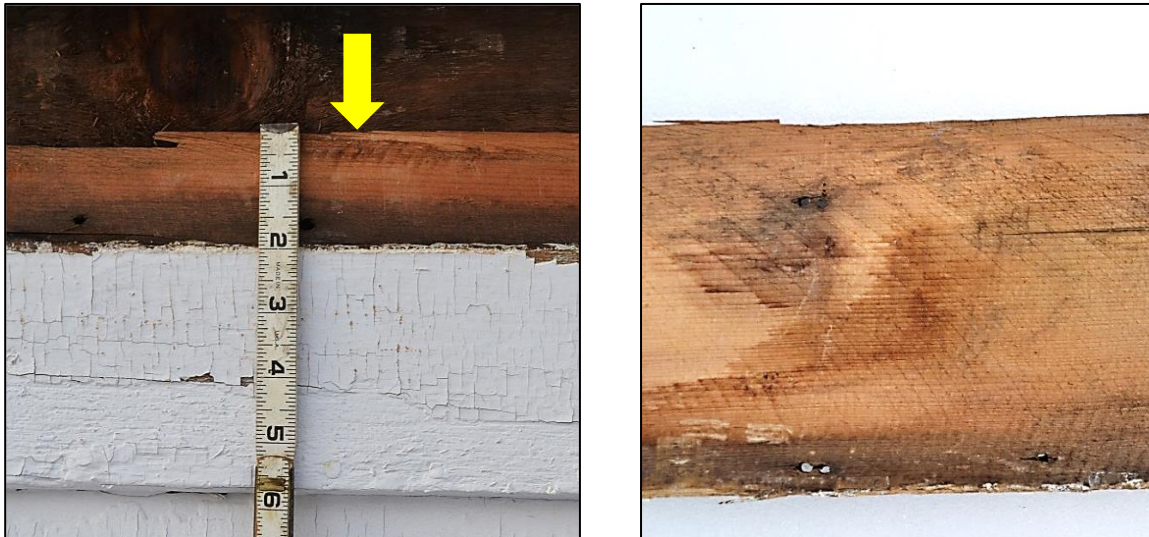
Clapboard on south wall of the Webster Meeting House, showing 5½-inch total clapboard width and 2-inch lap (left photo). Circular saw marks are visible on the face of the clapboards, (at the arrow), but are more pronounced on the back of the clapboards (right photo). The visible wood grain (annual rings) on the back of the clapboard indicates that this is a quarter-sawn clapboard of good quality, cut from a close-grained tree.

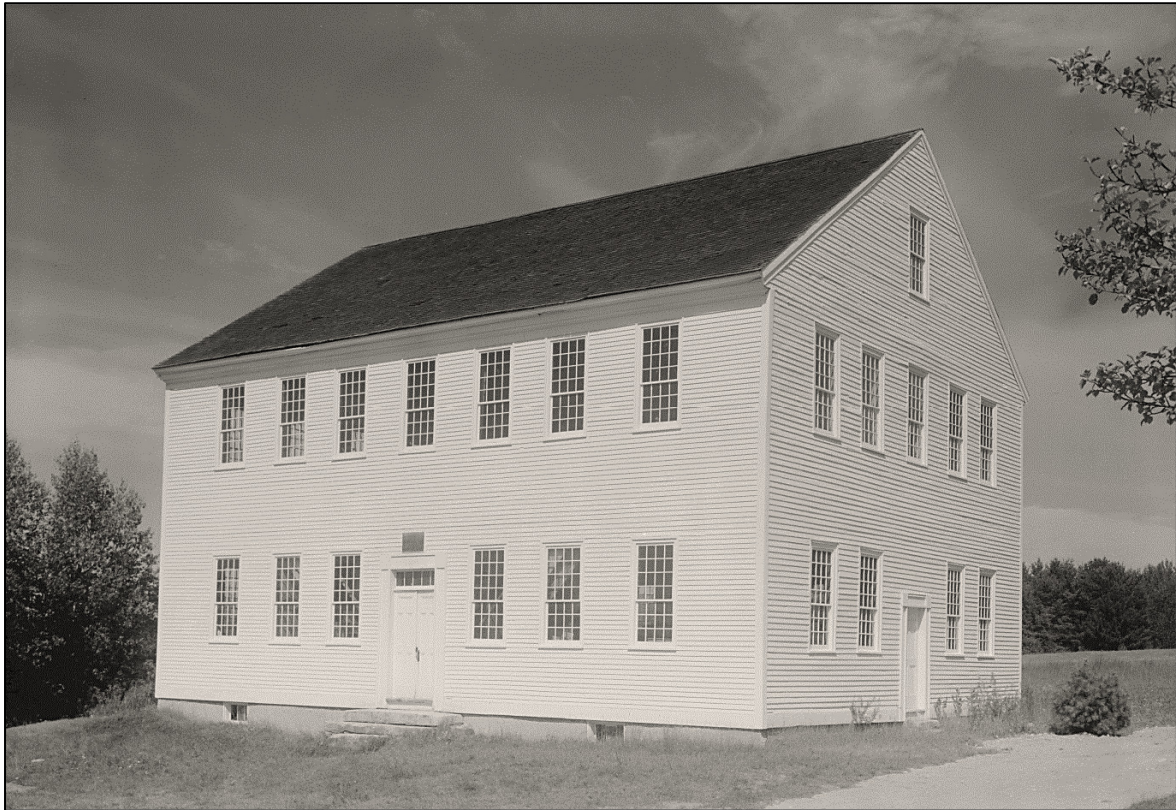
south gable of the building. These areas of clapboarding had apparently been replaced by the date of the 1979 photograph on page 7. These irregular areas likewise do not appear in photographs taken by Adele Sanborn for the National Register of Historic Places nomination of 1982 (listed 1984). This photographic evidence suggests that some areas of clapboards on the building have been replaced from time to time in recent decades.

Webster Meeting House, 1964. Historic American Buildings Survey (HABS NH-7—WEBS, 2-1), photograph by Gerda Peterich. Irregular or bulging clapboards are visible in the gable.

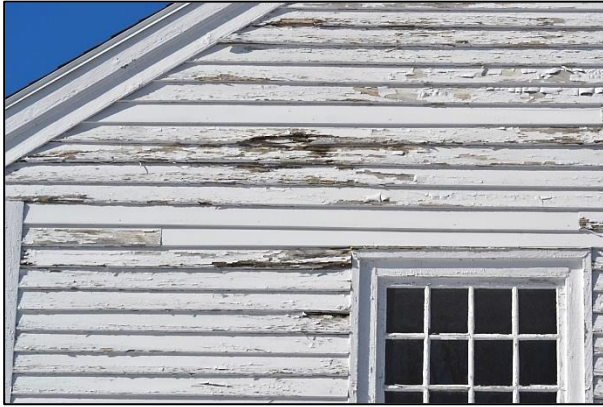
Whatever the cause—probably a combination of sunlight and the application of clapboard patches of varying wood species from time to time—the southern side of the building displays small areas of complete deterioration of clapboards, as seen on the following page. Possibly some replaced clapboards suffered from excess dampness or incipient dry rot when they were applied.

Top left: Area above westernmost window, south side, second story. March 2020.

On the southern elevation, all old clapboards will be replaced by quarter-sawn (radial sawn) clapboards of "extra clear" grade, using hot-dipped galvanized common nails.

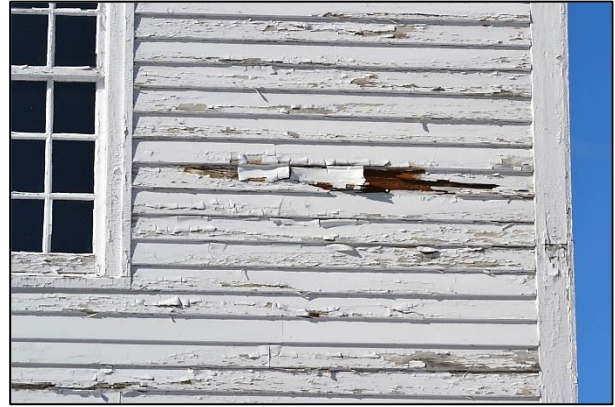
Top right: Area east of easternmost window, south side, second story. March 2020.

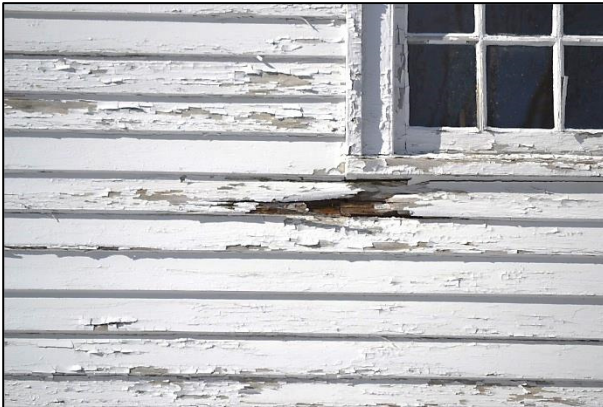
Left: Area below westernmost window, south side, second story. The location of this deterioration suggests the possibility that rainwater leakage occurs at the left-hand casing or the sill of the window.

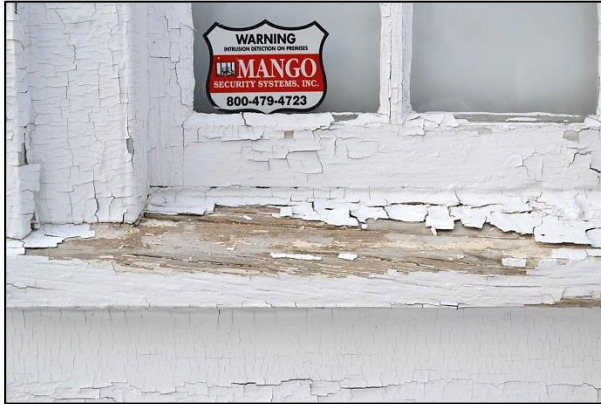
It should be noted that some of the wooden window sills of the building have cracked due to exposure to the weather and sun. A few have had areas of decay or splitting removed and wooden patches or “Dutchmen” installed. All window sills should be studied to assess the need for further repairs, consolidation, or replacement.

Left: Cracked or checked window sill, south side of building.

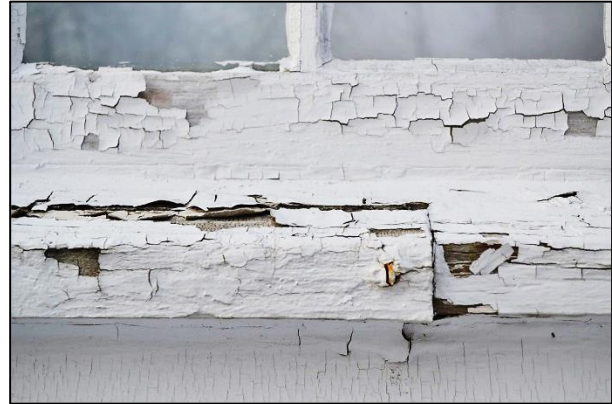
Right: Infill (“Dutchman”) repair to window sill, south side of building.

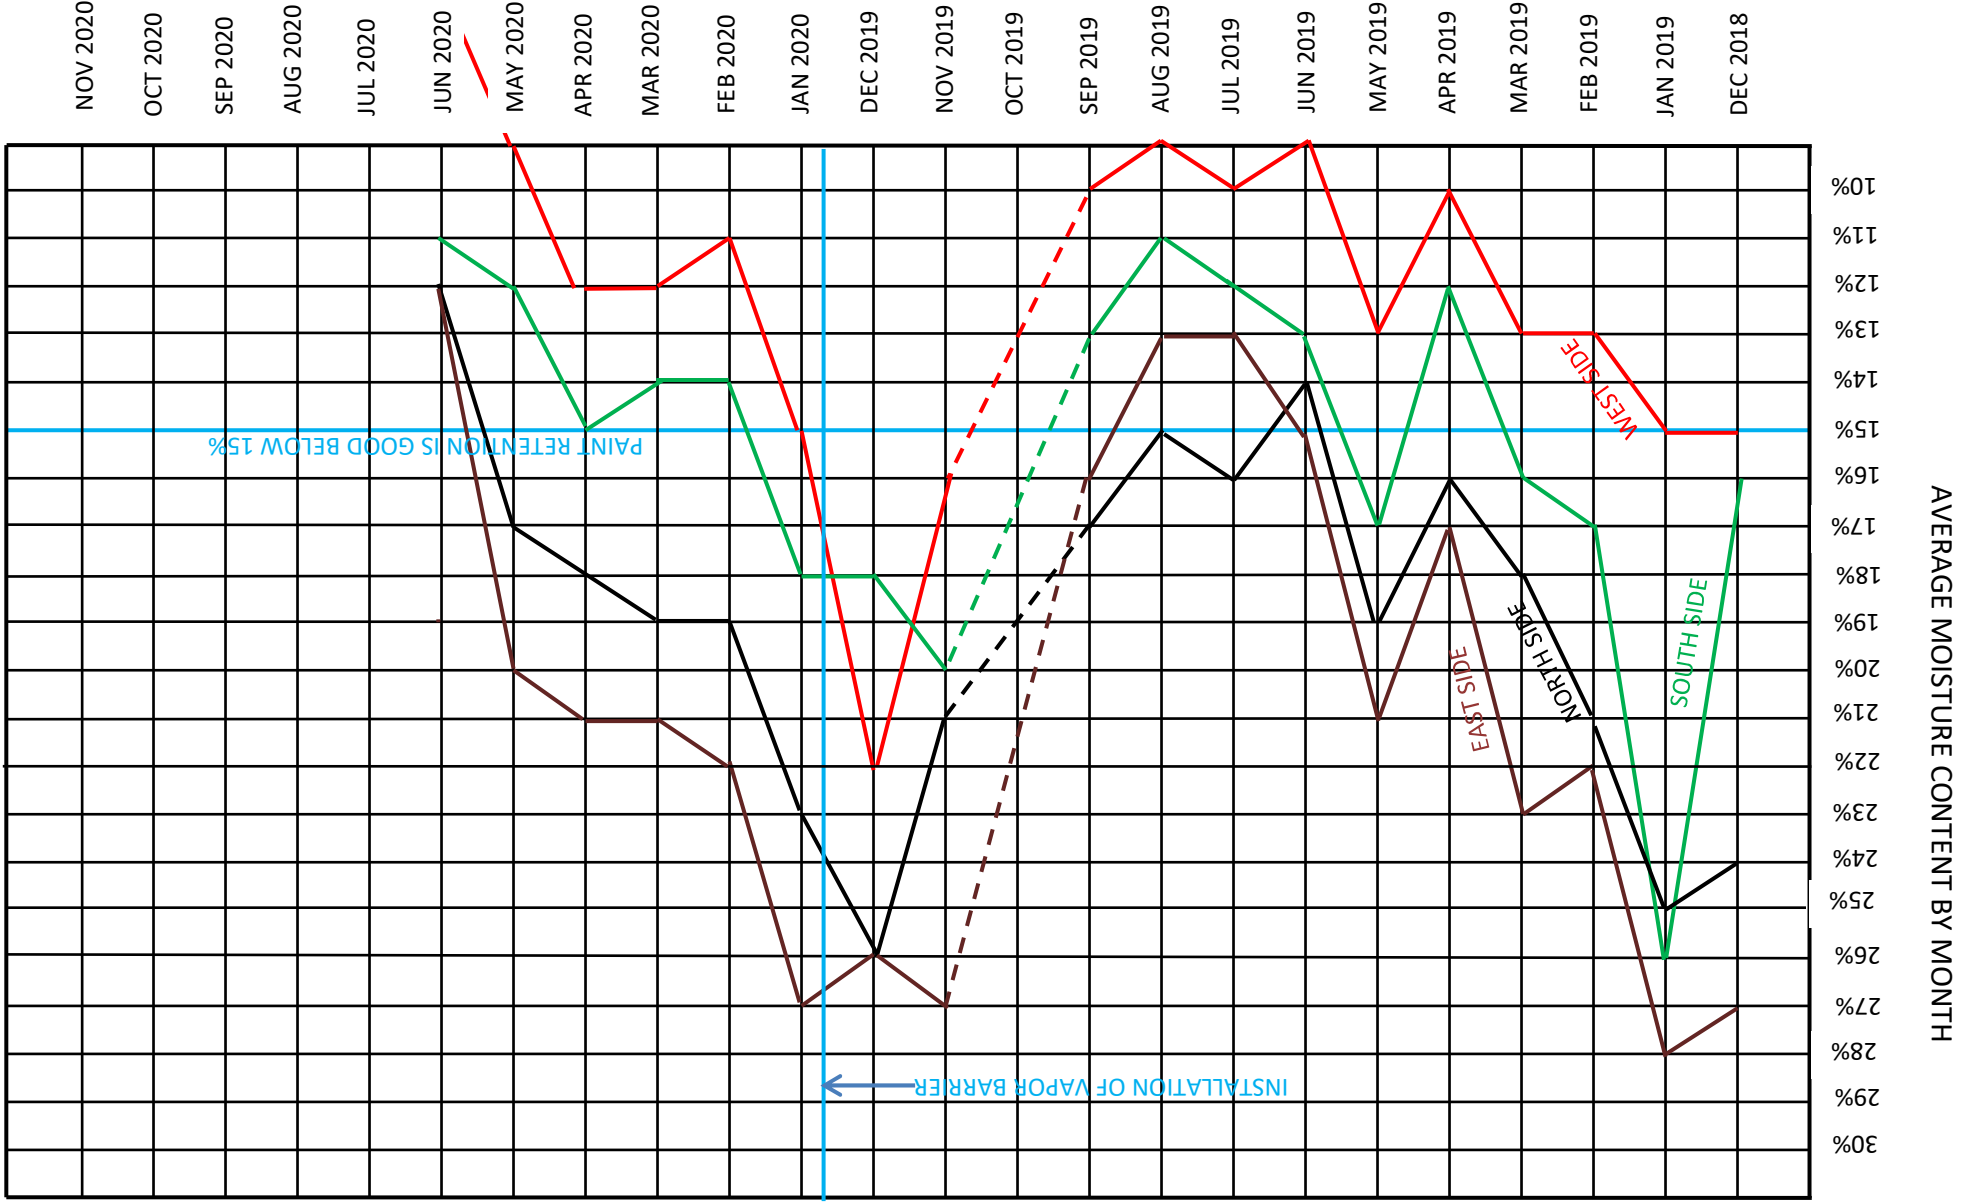
OLD WEBSTER MEETING HOUSE CLAPBOARD MOISTURE CONTENT BY MONTH

As seen in the following graph, the moisture content in the clapboards has been excessive. Under normal conditions, clapboards will retain good quality paint when the wood has a moisture content of 15% or lower. As shown in the graph, the clapboards on the sunlit south and west sides of the building fell within or just above this range during the summer months of 2019 and are again returning to those levels in the spring of 2020. On the north and east sides of the building, however, the moisture content has generally exceeded the recommended range during most months of the year. A robust vapor barrier was professionally installed in the basement in late December 2019. Moisture levels are expected to drop and remain below 15% on all sides of the building, and will be closely monitored for the indefinite future.

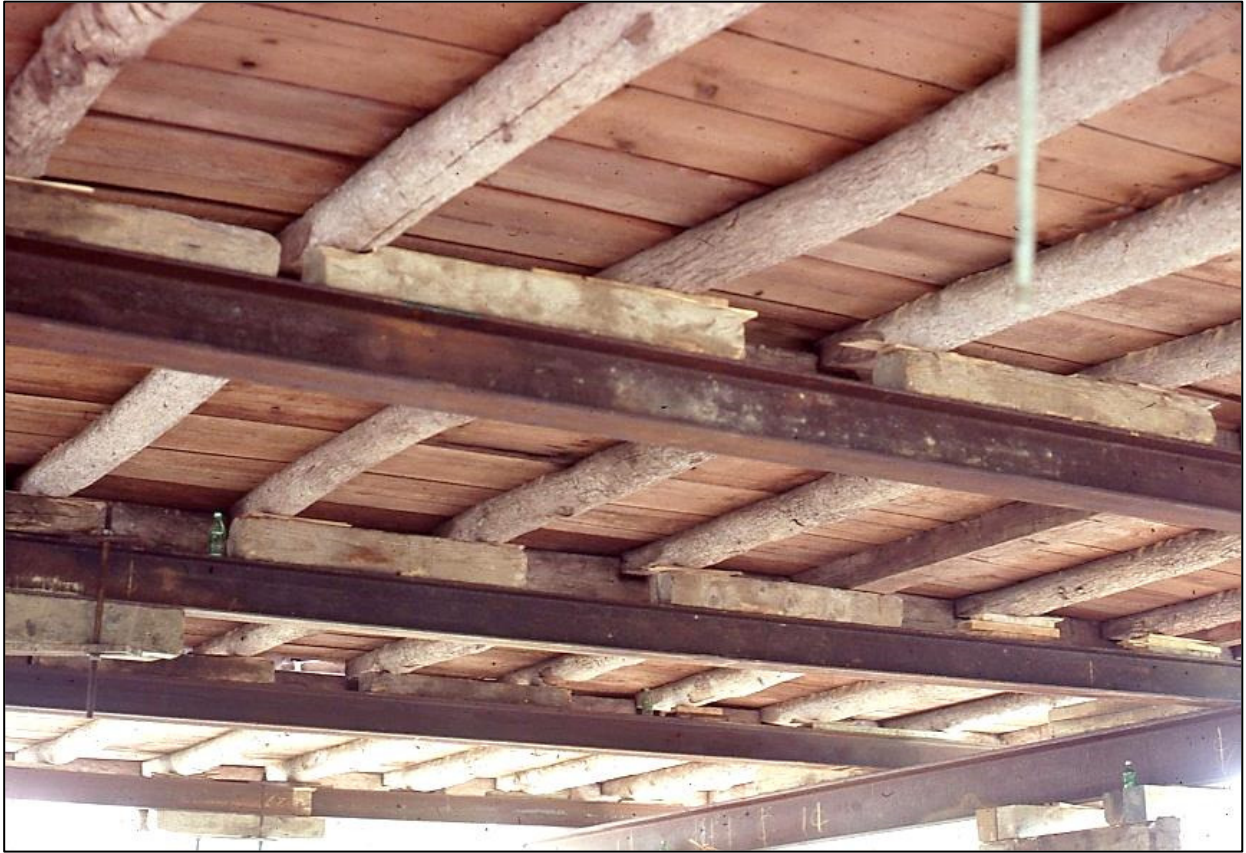
First floor frame, camera facing northeast, June 1979. The east-west floor girders support the ends of rounded sleepers. The steel beams were inserted temporarily during the lifting of the building. Photograph by James L. Garvin.

As seen in these photographs, the condition of the first-floor framing was excellent in 1979. Throughout its history until that time, the meeting house had stood above a very shallow crawl space, a characteristic that is typical of almost all eighteenth-century meeting houses. Even after the building was moved to its present site in 1941-2, it was replaced on underpinning stones set at grade level, providing only a shallow space under the structure. As seen in other meeting houses, such shallow crawl spaces are usually not ventilated. Typically, these spaces remain very dry. In several meeting houses dating from the 1700s and early 1800s, wood chips and shavings from the construction of the building are well preserved on the dry ground under the structure, having been unaffected by dampness for two centuries or more.

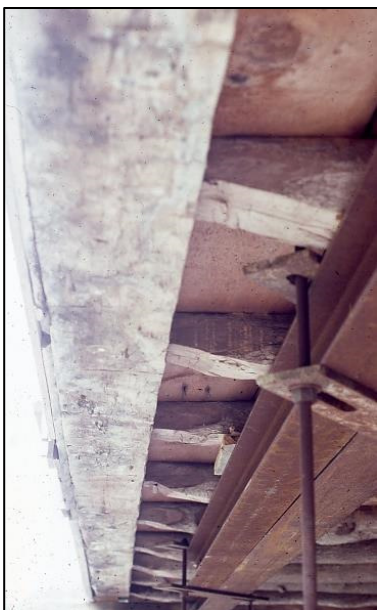
Left: North sill, camera facing east, June 197. Garvin photograph.

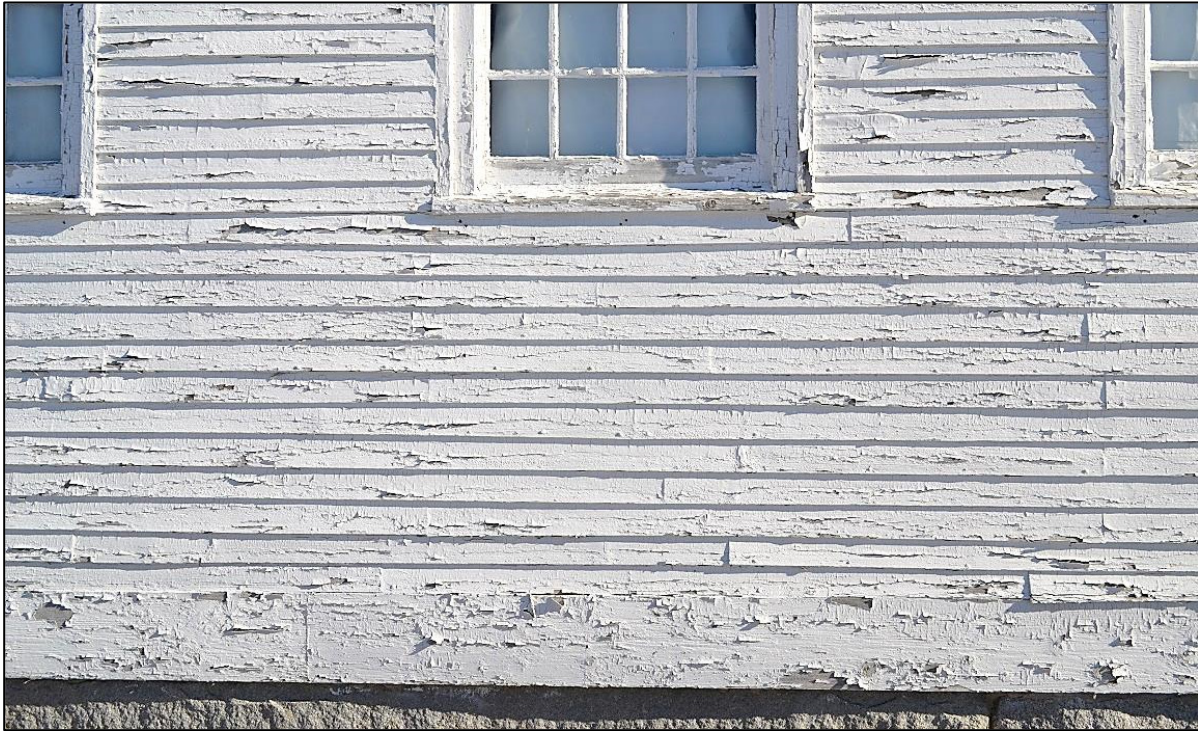
Current condition of the exterior paint. The data above show that excessive moisture content is concentrated in the exterior skin of the building, specifically in the clapboards and presumably in the sheathing boards that underlie the clapboards. The result of this moisture content is paint failure, as seen below.

Water table, clapboards, and window casings on the west side of the Webster Meeting House, January 2, 2019.

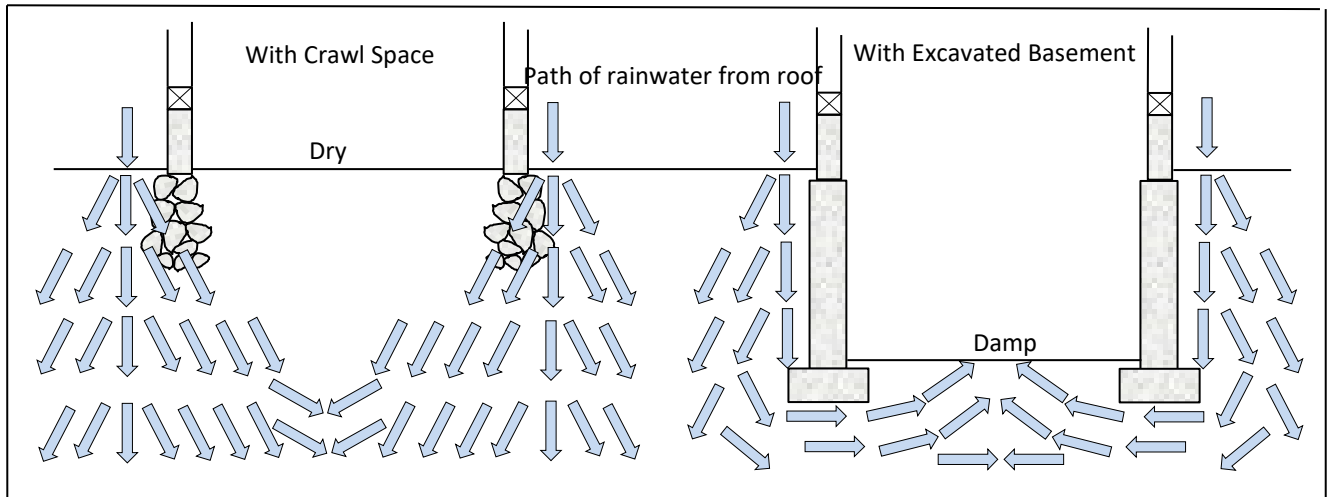
As seen in the drawings below, the deepening of the basement in 1979 created a situation where water from the roof of the building could find its way back inside the structure. With only a shallow crawl space, the earth under a meeting house typically remains very dry—dry enough to preserve wooden chips and shavings for 200 years or more. A deepened basement, on the other hand, provides a “well” beneath the building where water from the roof may migrate under the

building and saturate the ground to the elevation of the lowered cellar floor. If the floor is uncovered earth, the water may then be free to escape inside the building.
