WEBSTER MEETING HOUSE HISTORIC BUILDING ASSESSMENT

1220 BATTLE STREET
WEBSTER, NEW HAMPSHIRE
JUNE 2020

Assessment of Condition (with graph of moisture conditions)

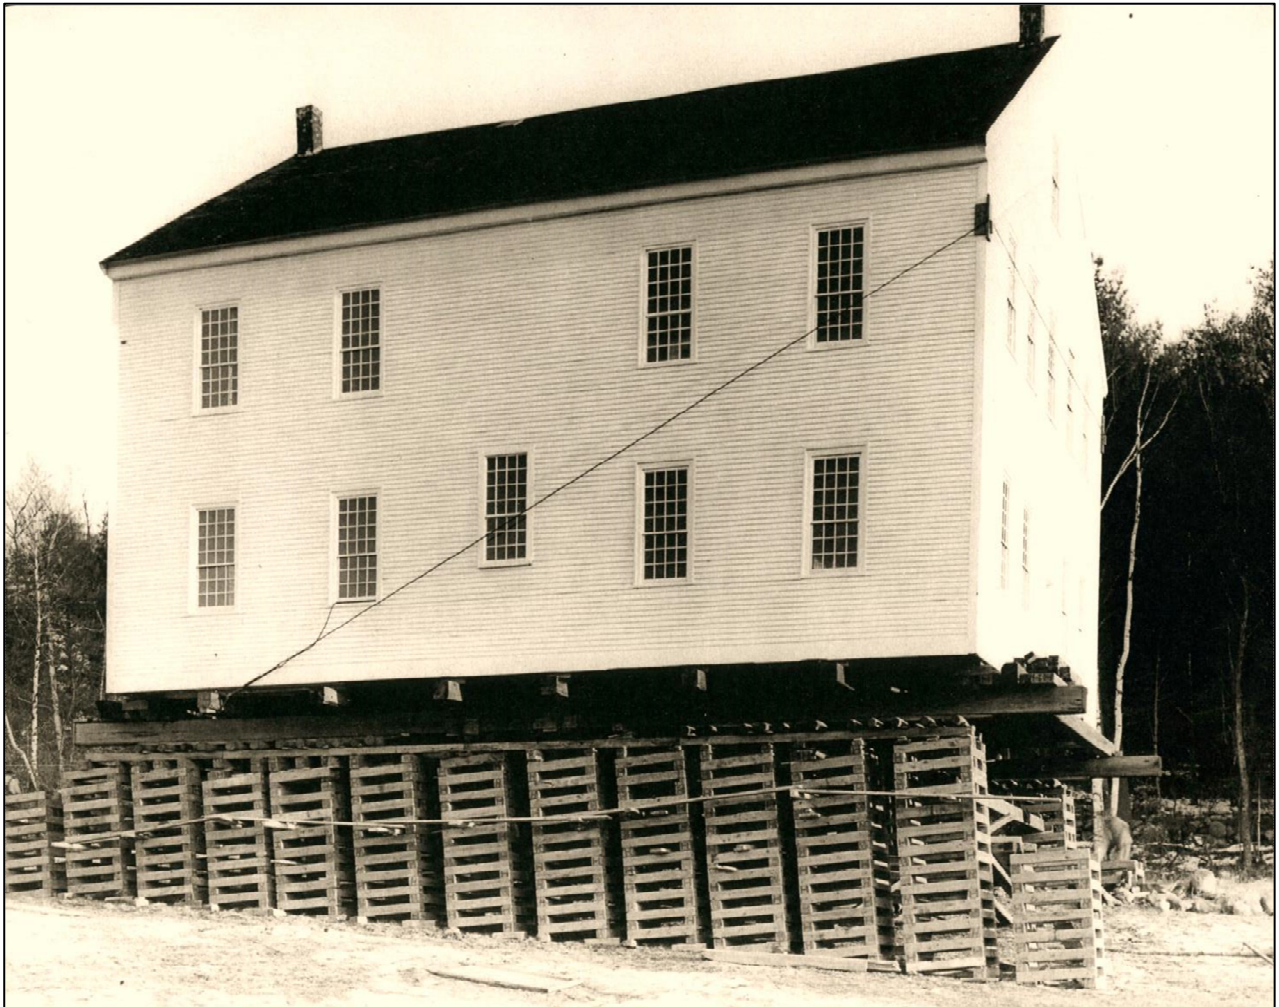
Walter Hill Company moving the meeting house northeasterly from its original location to a temporary site near the intersection of Battle Street and Long Street in the fall of 1941. Hill placed the building at its current location in the late spring of 1942. The move was carried out slowly, using a single horse to turn a capstan that was progressively anchored at intervals along the gravel roadway. Seen in this photograph is the rear side of the building, originally the northern elevation. In the building's new location, the rear elevation faces east. Courtesy of the Webster Historical Society.

Walter Hill Company of Tilton moved the building to its current location in the spring of 1942. The relocation required that the building be rotated 90° on its new site, with the original south (main) doorway now facing west.⁵

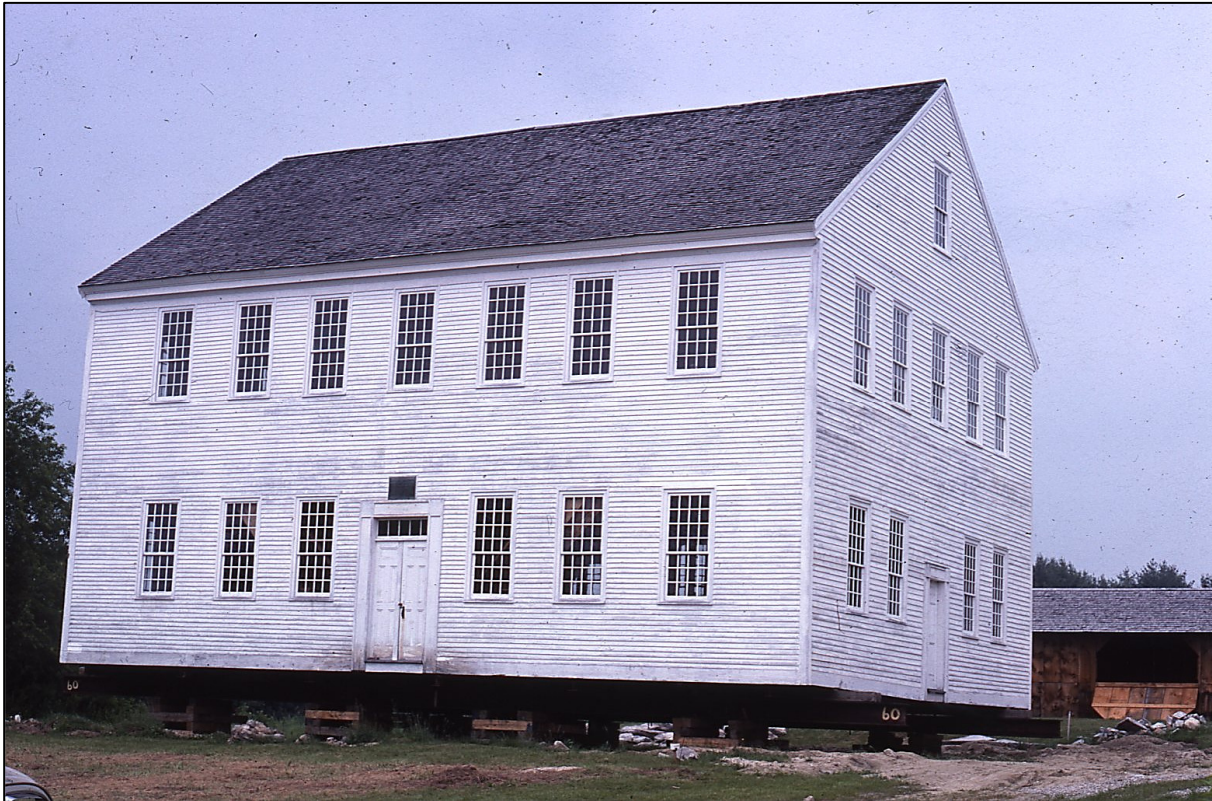
Temporary jacking of the meeting house in 1979 for the construction of a concrete foundation below grade. Photograph by James L. Garvin, June 1979.

1979 The Society for the Preservation of the Old Meeting House in Webster had the building lifted temporarily to permit the excavation of a deepened crawl space and the construction of concrete foundation walls below grade. The former granite underpinning stones were replaced above grade and the building was lowered onto its new foundation. The electrical service was updated.

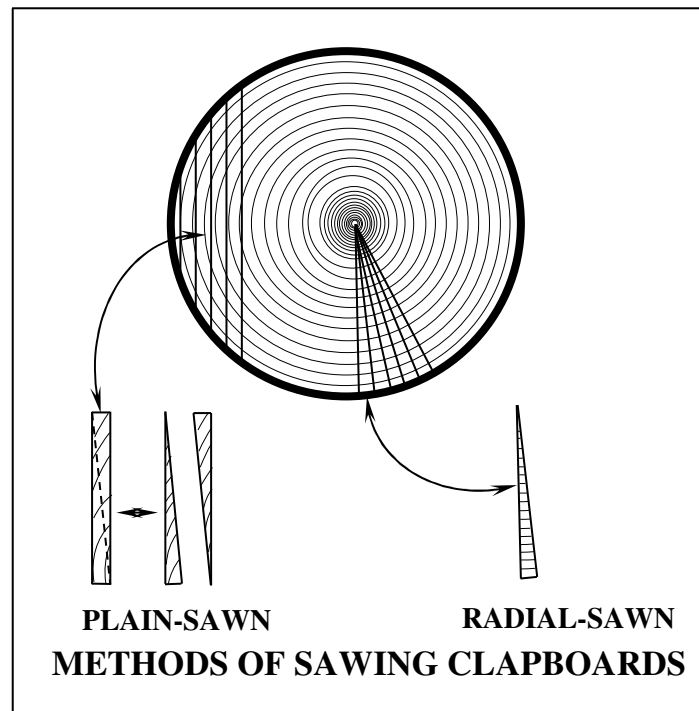
As described below and shown in the preceding drawing, the clapboards now covering the Webster Meeting House are sawn radially. This traditional method of sawing clapboards replicates the grain orientation that would have been found on the hand-split or riven clapboards used on the meeting house in 1791. By contrast, the currently common method of producing clapboards cuts plain-sawn boards from a log and then re-saws these boards into clapboards using a band-saw, as shown to the left of the preceding drawing. This method of production causes the grain to lie at an angle with the axis of the clapboard, encouraging warping and splitting of the board as the weather and humidity change over time.

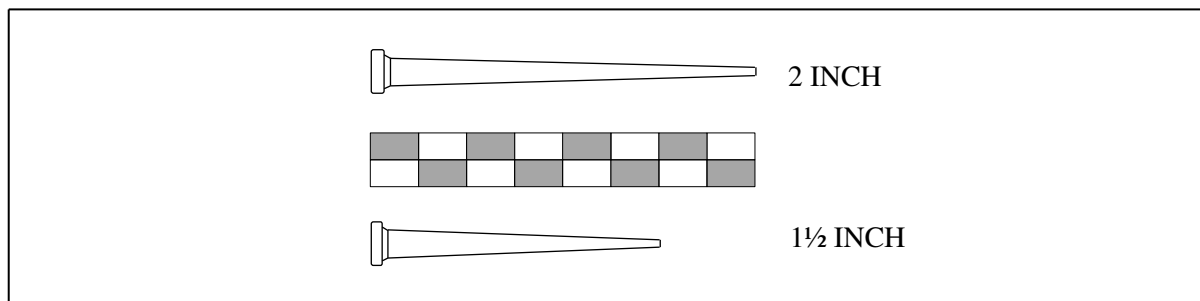
Nails: The cut clapboard nails that are original to these clapboards are found in two lengths as shown below. Cut nails are machine-made nails. The earliest examples were introduced in the very late 1700s, but were not available in all areas in the first years of their introduction because of limited numbers of nail factories and limited commercial connections between points of manufacture and rural hardware dealers. The fact that wrought nails were used in the floorboards of the first story of the building indicates that the original clapboards on the Webster Meeting House would likewise have been fastened with hand-forged nails rather than with cut nails.

The cut nails now seen on accessible areas of the building are technologically of a late type that was prevalent from the mid-1800s until well after the introduction of the wire nail in the 1890s. These nails are consistent with a date around 1900. It is likely that the original clapboards were at least partially replaced when the building was adapted from its original form into a two-story building that combined a town house and a chapel. This change removed the exterior stair “porches” at each end of the building and would have required the clapboarding of areas that had been enclosed by the porches. Some window and door changes occurred at this time, likewise requiring new clapboards in certain areas.

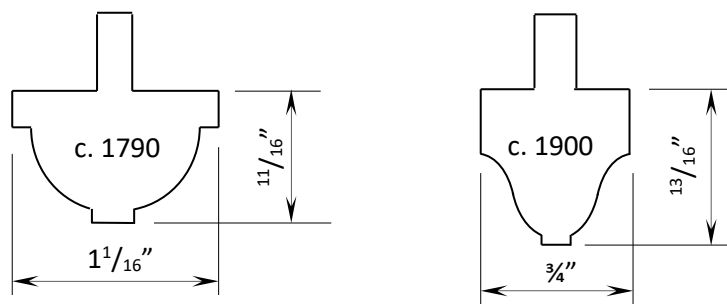
As seen in the photographs on the preceding pages, both the first and second stories of the building are lighted by 16-over-12 sashes. The attic windows are 12-over-12. Almost all the sashes have the late muntin profile shown below at the right, but one set, to the north of the reading desk or pulpit on the second story, has muntins of an eighteenth-century profile and appears to survive from the original construction of the building.

Although most sashes in the building appear to date from the restoration of 1902, the building retains one pair of sashes that are much older, as shown above. Like the window casing around the attic window on the south gable, this set of sashes provides important evidence of the original architectural character of the building and should be carefully preserved
